# Home Report

<b>Property address</b>	Langholm Farm Ochiltree Cumnock KA18 2LS
<b>Customer</b>	Mr Templeton
<b>Customer address</b>	Langholm Farm Ochiltree Cumnock KA18 2LS
<b>Prepared by</b>	Shepherd Chartered Surveyors
<b>Date of inspection</b>	31/10/2024

# Structural Appraisal Report

Langholm  
By Ochiltree  
East Ayrshire  
KA18 2LS

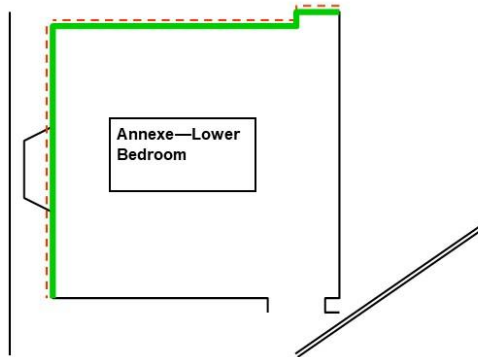
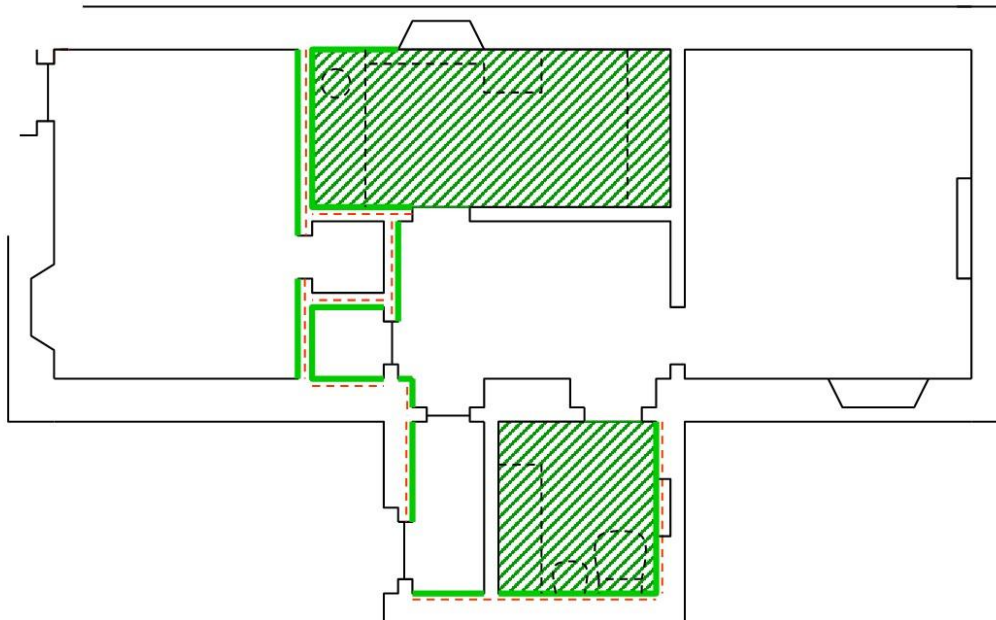
Part Ground Floor Plan

| | Chemical DPC | | Renew flooring, joists, wallplate, etc | | Woodworm treatment to Main and Porch Roofs | | Renew lintel |
