Home Report

Scottish Single Survey

Property address	19 Drummond Crescent Inverness IV2 4QR
Customer	Lisa & Jason Lugton
Customer address	19 Drummond Crescent Inverness IV2 4QR
Prepared by	Shepherd Chartered Surveyors
Date of inspection	24/09/2024

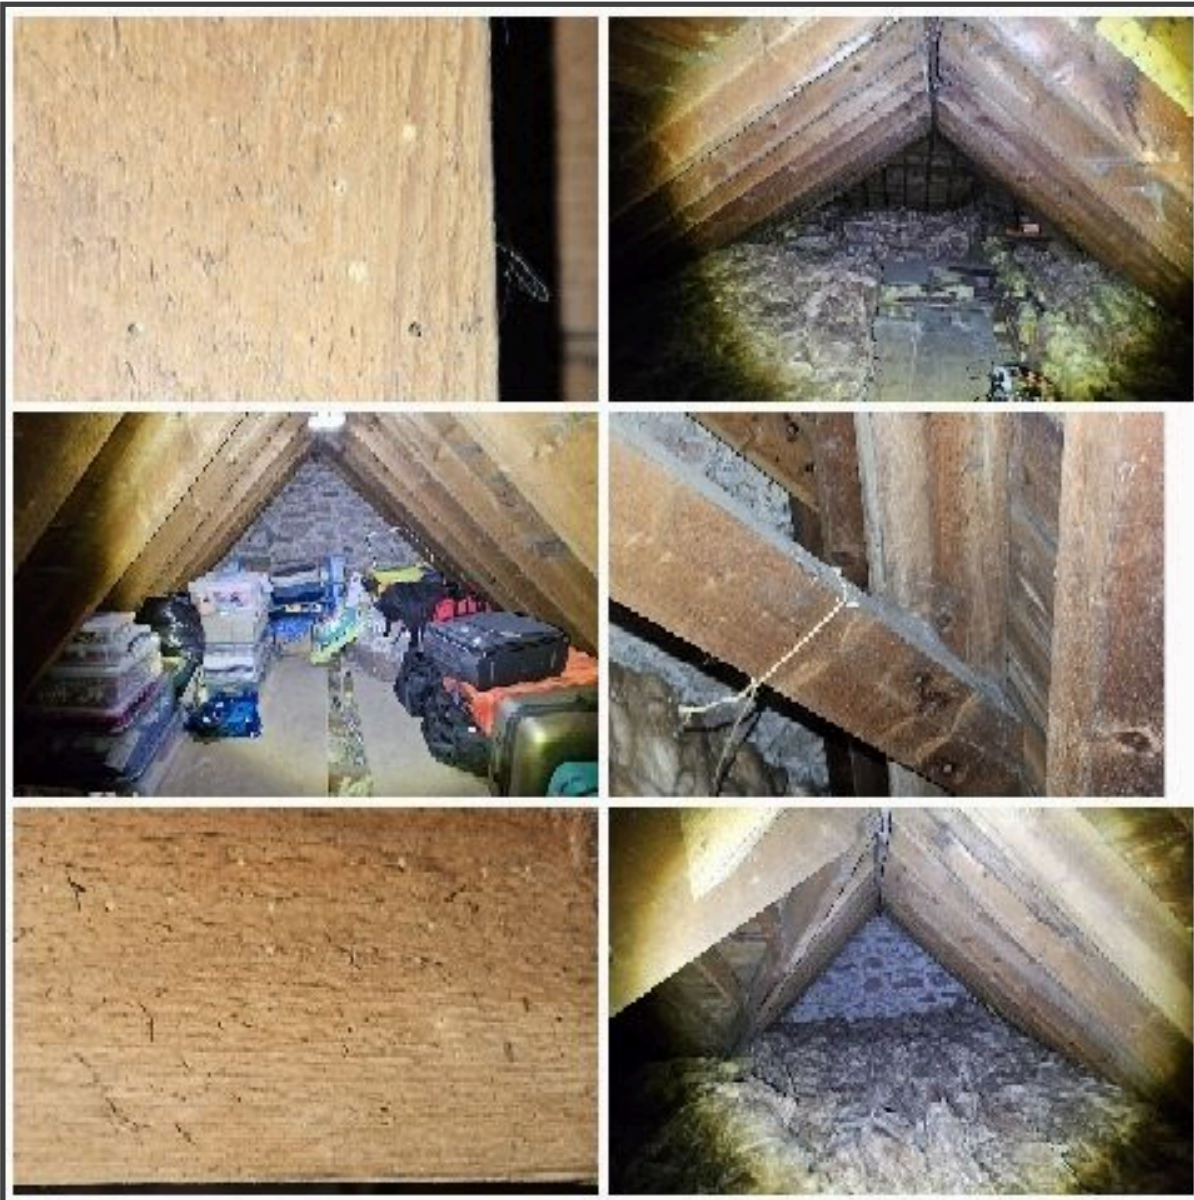
Where inspection was possible a slight to moderate concentrated infestation by common furniture beetle (*anobium punctatum*) was noted to the joinery timbers throughout the main roof void. At the time of inspection fresh frass indicated the infestation was active and requires treatment.

TREATMENT RECOMMENDED
