HOME REPORT

MAINS OF AUCHINDACHY

KEITH
AB55 5HT

Energy Performance Certificate (EPC)

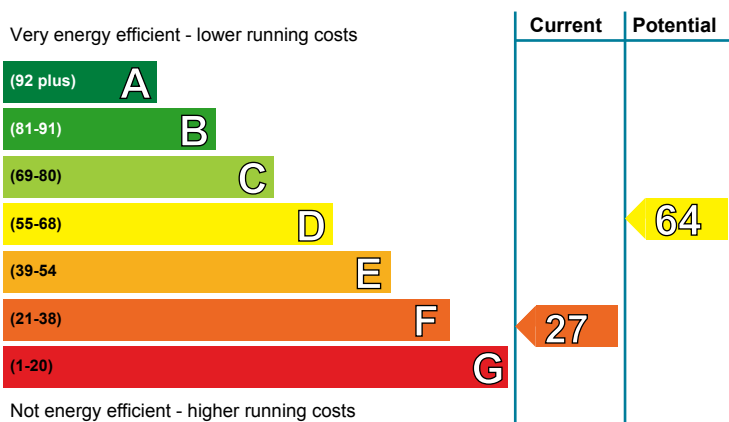
Energy Efficiency Rating

This graph shows the current efficiency of your home, taking into account both energy efficiency and fuel costs. The higher this rating, the lower your fuel bills are likely to be.

Your current rating is **band F (27)**. The average rating for EPCs in Scotland is **band D (61)**.

The potential rating shows the effect of undertaking all of the improvement measures listed within your recommendations report.

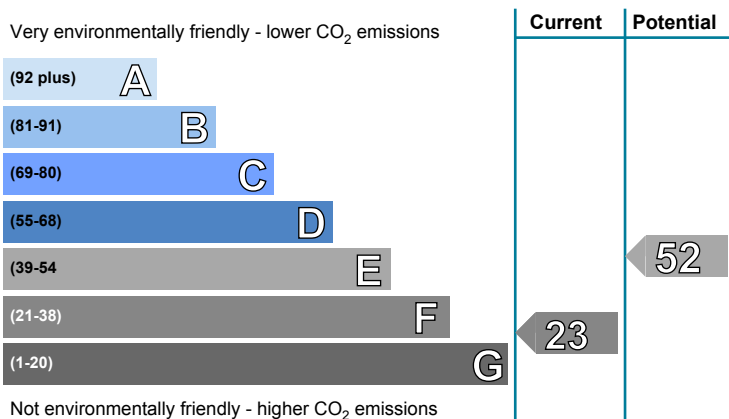
Environmental Impact (CO₂) Rating

This graph shows the effect of your home on the environment in terms of carbon dioxide (CO₂) emissions. The higher the rating, the less impact it has on the environment.

Your current rating is **band F (23)**. The average rating for EPCs in Scotland is **band D (59)**.

The potential rating shows the effect of undertaking all of the improvement measures listed within your recommendations report.

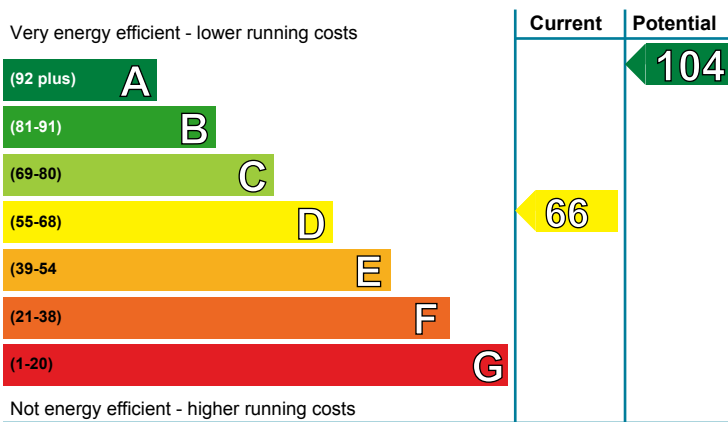
Energy Efficiency Rating

This graph shows the current efficiency of your home, taking into account both energy efficiency and fuel costs. The higher this rating, the lower your fuel bills are likely to be.

Your current rating is **band D (66)**. The average rating for EPCs in Scotland is **band D (61)**.

The potential rating shows the effect of undertaking all of the improvement measures listed within your recommendations report.

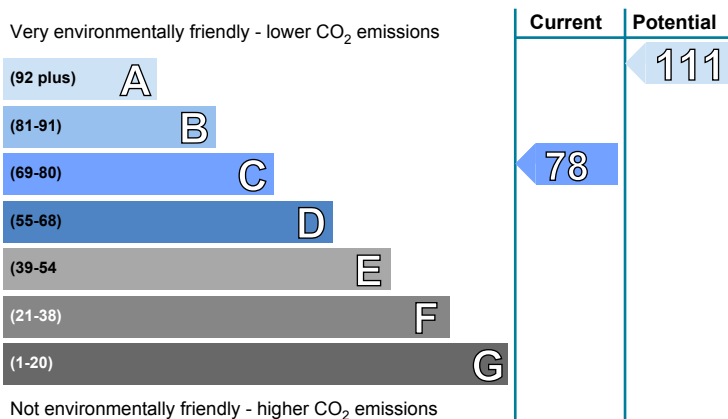
Environmental Impact (CO₂) Rating

This graph shows the effect of your home on the environment in terms of carbon dioxide (CO₂) emissions. The higher the rating, the less impact it has on the environment.

The potential rating shows the effect of undertaking all of the improvement measures listed within your recommendations report.
