# Home Report

Tigh-Na-Roinn Invermoriston  
Inverness IV63 7YE

# Single Survey

<b>Property Address</b>	Tigh-Na-Roinn Invermoriston Inverness IV63 7YE
<b>Customer</b>	Mr & Mrs Nick Curley
<b>Prepared by</b>	Graham + Sibbald LLP
<b>Date of Inspection</b>	25/02/2025

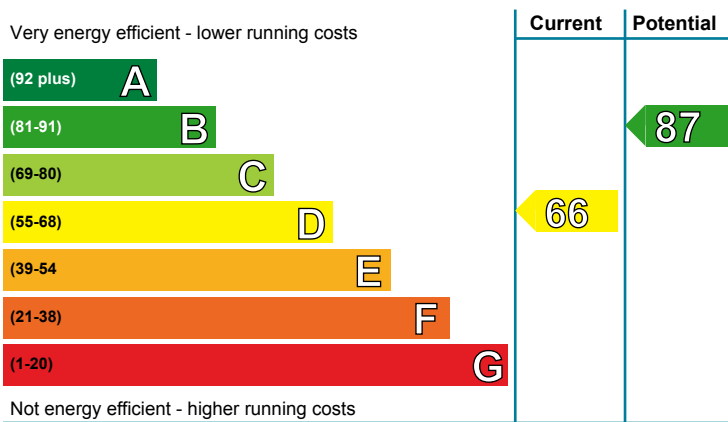
## Energy Efficiency Rating

This graph shows the current efficiency of your home, taking into account both energy efficiency and fuel costs. The higher this rating, the lower your fuel bills are likely to be.

Your current rating is **band D (66)**. The average rating for EPCs in Scotland is **band D (61)**.

The potential rating shows the effect of undertaking all of the improvement measures listed within your recommendations report.

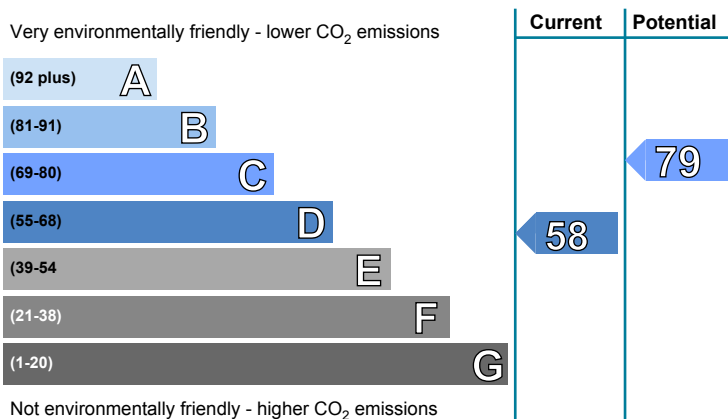
## Environmental Impact (CO<sub>2</sub>) Rating

This graph shows the effect of your home on the environment in terms of carbon dioxide (CO<sub>2</sub>) emissions. The higher the rating, the less impact it has on the environment.
