# Home Report

Seaside House 12 Shore Street Avoch IV9 8QD

### survey report on:

Property address	Seaside House 12 Shore Street Avoch IV9 8QD
Customer	Mrs Mary Allen

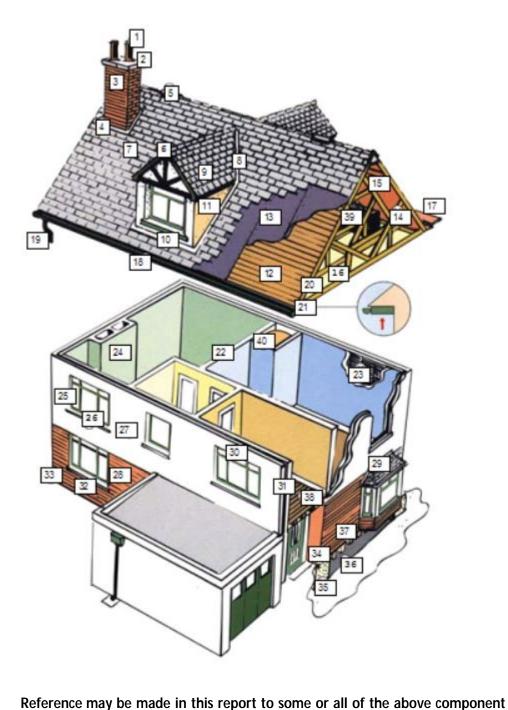
### Sectional Diagram showing elements of a typical house

Chimney pots 1 2 Coping stone 3 Chimney head Flashing 4 Ridge ventilation 5 Ridge board 6 7 Slates/tiles 8 Valley guttering 9 Dormer projection Dormer flashing 10 Dormer cheeks 11 12 Sarking Roof felt 13 Trusses 14 15 Collar 16 Insulation 17 Parapet gutter Eaves guttering 18 Rainwater downpipe 19 20 Verge boards / skews 21 Soffit boards 22 Partition wall Lath / plaster 23 24 Chimney breast 25 Window pointing Window sills 26 Rendering 27 Brickwork / pointing 28 Bay window 29 30 Lintels 31 Cavity walls / wall ties Subfloor ventilator 32 33 Damp proof course 34 Base course 35 Foundations Solum 36 37 Floor joists Floorboards 38 Water tank 39 40 Hot water tank parts of the property. This diagram may assist you in locating and understanding

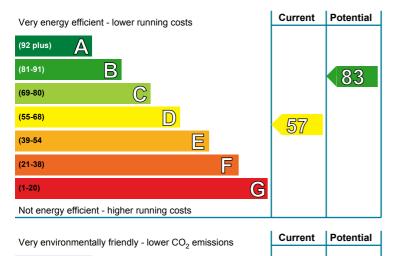
#### **Energy Efficiency Rating**

This graph shows the current efficiency of your home, taking into account both energy efficiency and fuel costs. The higher this rating, the lower your fuel bills are likely to be.
