HOME REPORT

NORTH BALDINNIE BALDINNIE

CUPAR
KY15 5LE

DM HALL
CHARTERED SURVEYORS

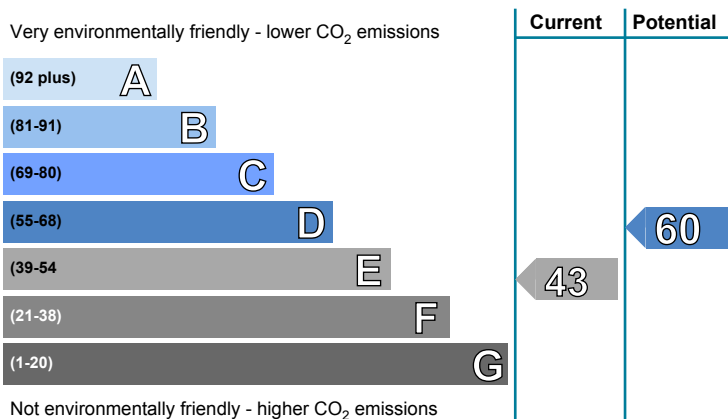
Environmental Impact (CO₂) Rating

This graph shows the effect of your home on the environment in terms of carbon dioxide (CO₂) emissions. The higher the rating, the less impact it has on the environment.

Your current rating is **band E (43)**. The average rating for EPCs in Scotland is **band D (59)**.

The potential rating shows the effect of undertaking all of the improvement measures listed within your recommendations report.
