Home Report

Scottish Single Survey

Property address	Burnton Farm New Cumnock CUMNOCK KA18 4NW
Customer	Scottish Woodlands Ltd
Customer address	Burnton Farm New Cumnock CUMNOCK KA18 4NW
Prepared by	Shepherd Chartered Surveyors
Date of inspection	02/06/2023

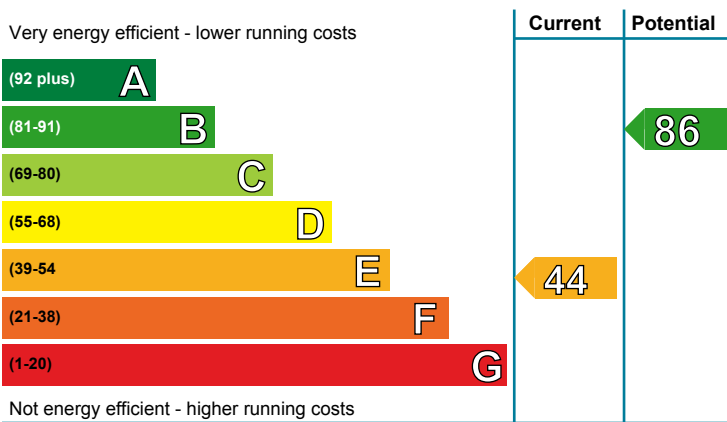
Energy Efficiency Rating

This graph shows the current efficiency of your home, taking into account both energy efficiency and fuel costs. The higher this rating, the lower your fuel bills are likely to be.

Your current rating is **band E (44)**. The average rating for EPCs in Scotland is **band D (61)**.

The potential rating shows the effect of undertaking all of the improvement measures listed within your recommendations report.
