Home Report

Scottish Single Survey

Property address	54 St. Andrew Street Castle Douglas DG7 1EN
Customer	Mrs Alison Morrison
Customer address	
Prepared by	Shepherd Chartered Surveyors
Date of inspection	21/05/2024

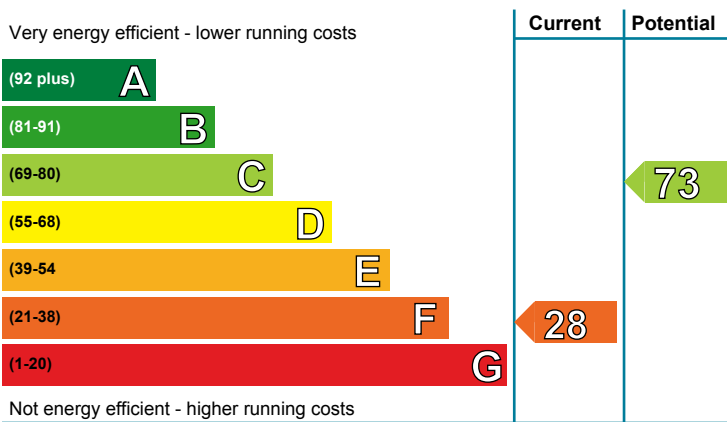
Energy Efficiency Rating

This graph shows the current efficiency of your home, taking into account both energy efficiency and fuel costs. The higher this rating, the lower your fuel bills are likely to be.

Your current rating is **band F (28)**. The average rating for EPCs in Scotland is **band D (61)**.

The potential rating shows the effect of undertaking all of the improvement measures listed within your recommendations report.

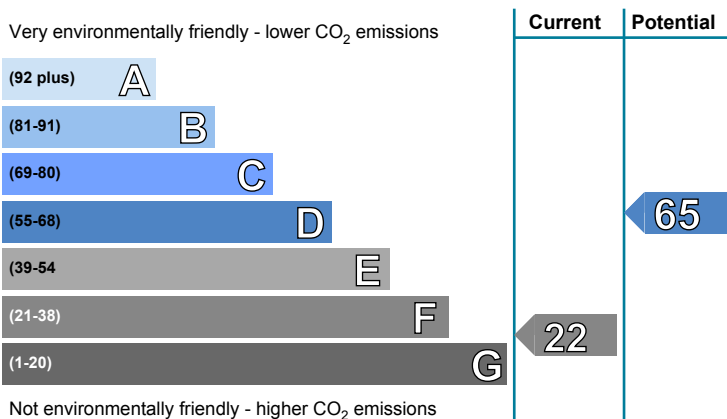
Environmental Impact (CO₂) Rating

This graph shows the effect of your home on the environment in terms of carbon dioxide (CO₂) emissions. The higher the rating, the less impact it has on the environment.
