Home Report

Mill of Kingcausie Newtonhill Stonehaven AB39 3PA

survey report on:

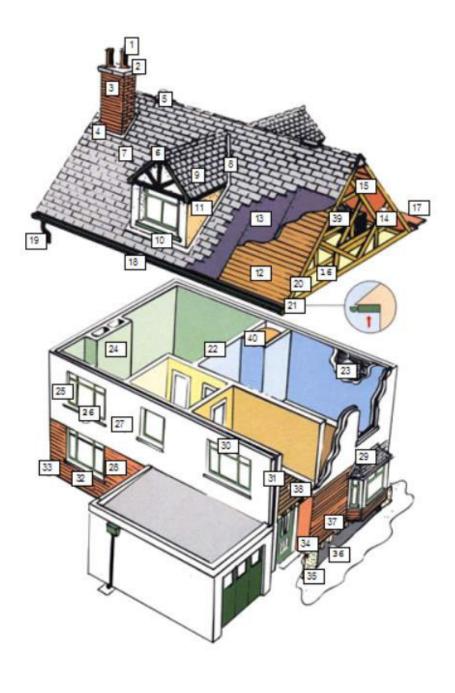
Sectional Diagram showing elements of a typical house

1	Chimney pots
2	Coping stone
3	Chimney head
4	Flashing
5	Ridge ventilation
6	Ridge board
7	Slates/tiles
8	Valley guttering
9	Dormer projection
10	Dormer flashing
11	Dormer cheeks
12	Sarking
13	Roof felt
14	Trusses
15	Collar
16	Insulation
17	Parapet gutter
18	Eaves guttering
19	Rainwater downpipe
20	Verge boards / skews
21	Soffit boards
22	Partition wall
23	Lath / plaster
24	Chimney breast
25	Window pointing
26	Window sills
27	Rendering
28	Brickwork / pointing
29	Bay window
	projection
30	Lintels
31	Cavity walls / wall ties
32	Subfloor ventilator
33	Damp proof course
34	Base course
35	Foundations
36	Solum
37	Floor joists
38	Floorboards
39	Water tank
40	Hot water tank
