HOME REPORT

MILL COTTAGE GLENRINNES

KEITH
AB55 4BY

Energy Performance Certificate (EPC)

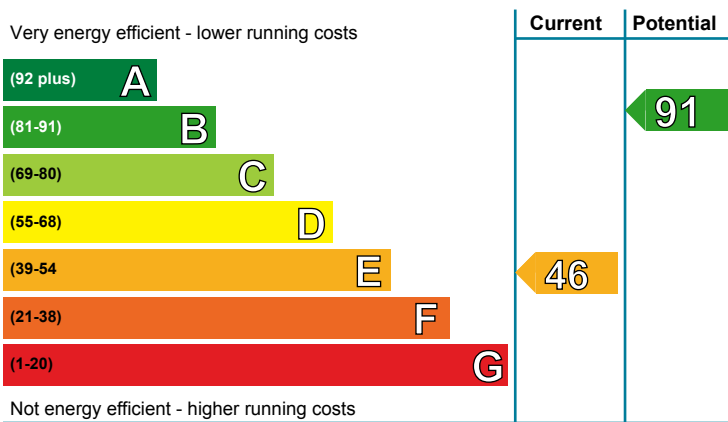
Energy Efficiency Rating

This graph shows the current efficiency of your home, taking into account both energy efficiency and fuel costs. The higher this rating, the lower your fuel bills are likely to be.

Your current rating is **band E (46)**. The average rating for EPCs in Scotland is **band D (61)**.

The potential rating shows the effect of undertaking all of the improvement measures listed within your recommendations report.

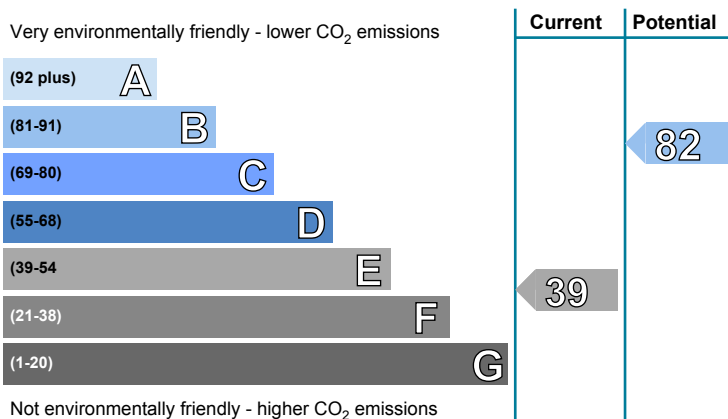
Environmental Impact (CO₂) Rating

This graph shows the effect of your home on the environment in terms of carbon dioxide (CO₂) emissions. The higher the rating, the less impact it has on the environment.

Your current rating is **band E (39)**. The average rating for EPCs in Scotland is **band D (59)**.

The potential rating shows the effect of undertaking all of the improvement measures listed within your recommendations report.
