Home Report

Scottish Single Survey

Property address	Gillespie Lodge Auchenmalg Glenluce Newton Stewart DG8 0JU
Customer	Michael & Susan Tipton
Customer address	Gillespie Lodge Auchenmalg Glenluce Newton Stewart DG8 0JU
Prepared by	Shepherd Chartered Surveyors
Date of inspection	26/03/2025

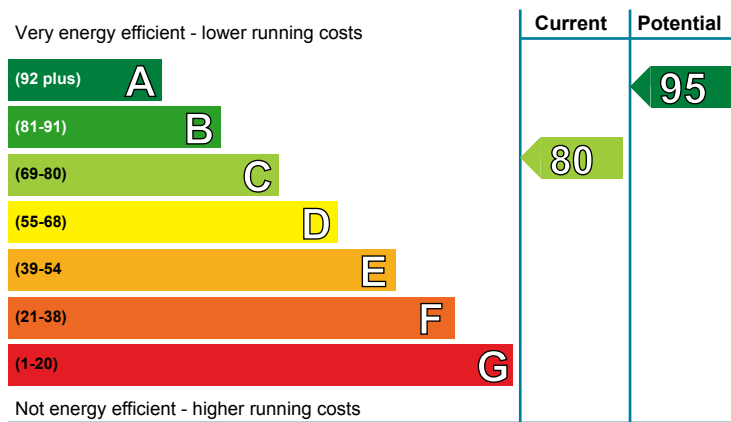
Energy Efficiency Rating

This graph shows the current efficiency of your home, taking into account both energy efficiency and fuel costs. The higher this rating, the lower your fuel bills are likely to be.

Your current rating is **band C (80)**. The average rating for EPCs in Scotland is **band D (61)**.

The potential rating shows the effect of undertaking all of the improvement measures listed within your recommendations report.

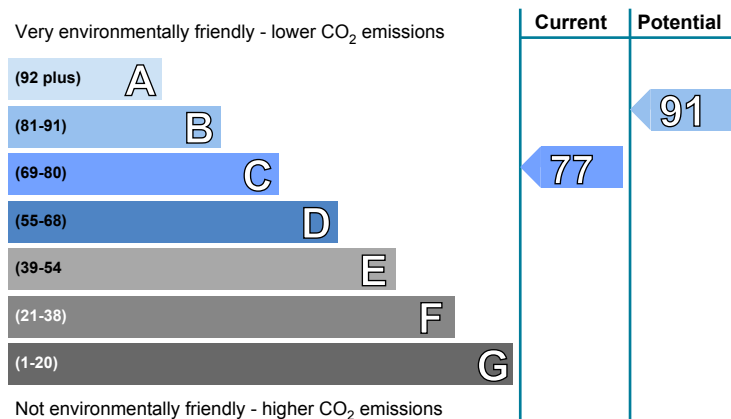
Environmental Impact (CO₂) Rating

This graph shows the effect of your home on the environment in terms of carbon dioxide (CO₂) emissions. The higher the rating, the less impact it has on the environment.
