Home Report

Scottish Single Survey

Property address	4 Station Road Cults Aberdeen AB15 9NP
-------------------------	---

Prepared by	Shepherd Chartered Surveyors
--------------------	------------------------------

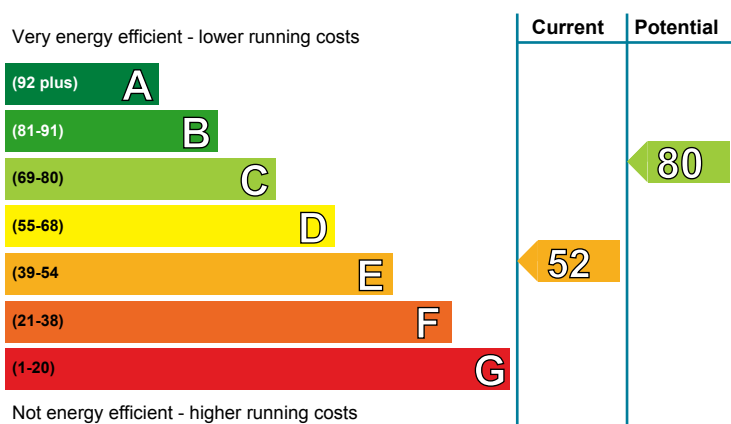
Energy Efficiency Rating

This graph shows the current efficiency of your home, taking into account both energy efficiency and fuel costs. The higher this rating, the lower your fuel bills are likely to be.

Your current rating is **band E (52)**. The average rating for EPCs in Scotland is **band D (61)**.

The potential rating shows the effect of undertaking all of the improvement measures listed within your recommendations report.

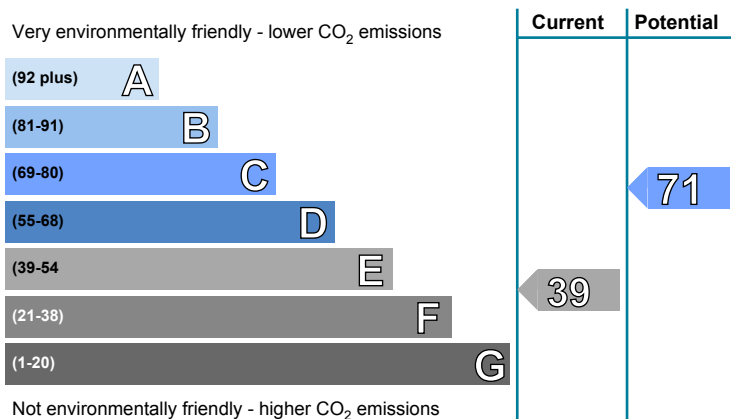
Environmental Impact (CO₂) Rating

This graph shows the effect of your home on the environment in terms of carbon dioxide (CO₂) emissions. The higher the rating, the less impact it has on the environment.
