Home Report

Scottish Single Survey

Property address	Grangehill Threepwood Road Beith KA15 2JJ
-------------------------	--

Prepared by	Shepherd Chartered Surveyors
--------------------	------------------------------

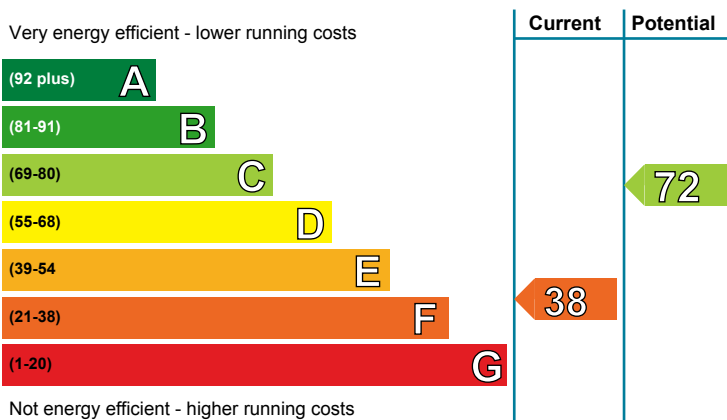
Energy Efficiency Rating

This graph shows the current efficiency of your home, taking into account both energy efficiency and fuel costs. The higher this rating, the lower your fuel bills are likely to be.

Your current rating is **band F (38)**. The average rating for EPCs in Scotland is **band D (61)**.

The potential rating shows the effect of undertaking all of the improvement measures listed within your recommendations report.

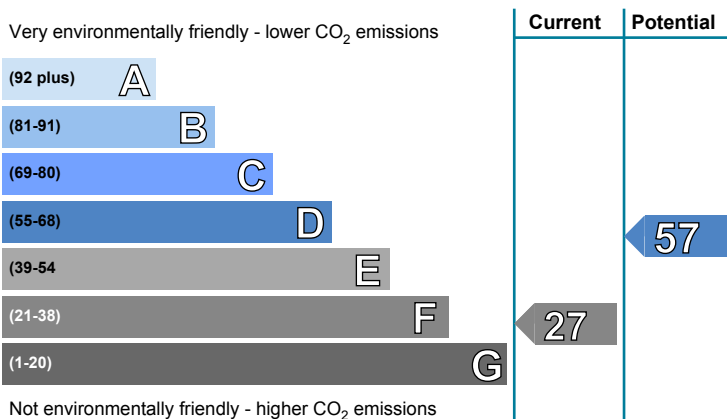
Environmental Impact (CO₂) Rating

This graph shows the effect of your home on the environment in terms of carbon dioxide (CO₂) emissions. The higher the rating, the less impact it has on the environment.
