Walker Fraser Steele  
Chartered Surveyors

MOSS SIDE CROFT PARKHILL DYCE

## Energy Performance Certificate

Dwellings

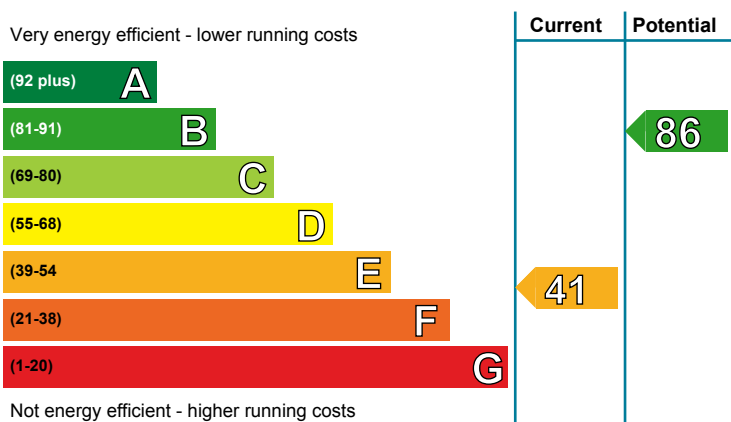
## Energy Efficiency Rating

This graph shows the current efficiency of your home, taking into account both energy efficiency and fuel costs. The higher this rating, the lower your fuel bills are likely to be.

Your current rating is **band E (41)**. The average rating for EPCs in Scotland is **band D (61)**.

The potential rating shows the effect of undertaking all of the improvement measures listed within your recommendations report.
