YOUR ONESURVEY
HOME REPORT

Mead Leys
Smiddy Wood
Strathpeffer
IV14 9AB

SINGLE SURVEY

Single Survey

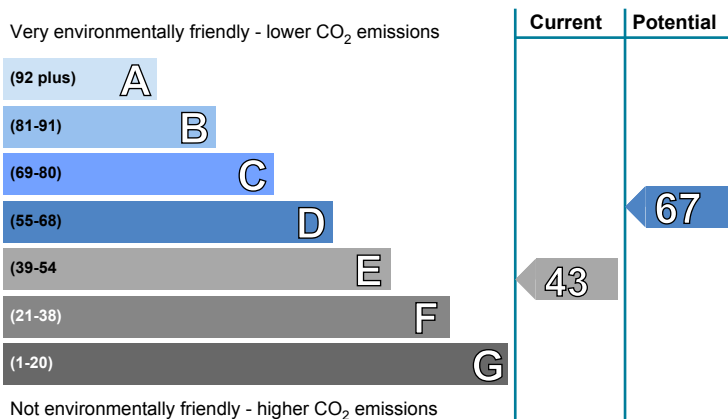
Environmental Impact (CO₂) Rating

This graph shows the effect of your home on the environment in terms of carbon dioxide (CO₂) emissions. The higher the rating, the less impact it has on the environment.
