HOME REPORT

NEWMILLS FARMHOUSE BALBLAIR

DINGWALL
IV7 8LP

Energy Performance Certificate (EPC)

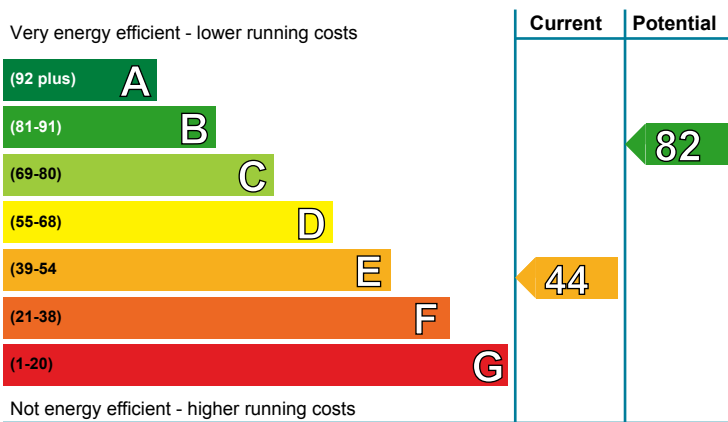
Energy Efficiency Rating

This graph shows the current efficiency of your home, taking into account both energy efficiency and fuel costs. The higher this rating, the lower your fuel bills are likely to be.

Your current rating is **band E (44)**. The average rating for EPCs in Scotland is **band D (61)**.

The potential rating shows the effect of undertaking all of the improvement measures listed within your recommendations report.
