Home Report

Scottish Single Survey

Property address	Ladyurd Cottages West Linton EH46 7DH
-------------------------	---

Prepared by	Shepherd Chartered Surveyors
--------------------	------------------------------

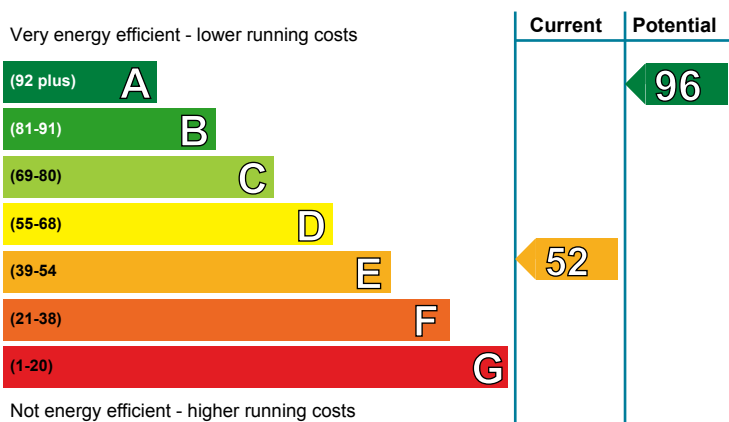
Energy Efficiency Rating

This graph shows the current efficiency of your home, taking into account both energy efficiency and fuel costs. The higher this rating, the lower your fuel bills are likely to be.

Your current rating is **band E (52)**. The average rating for EPCs in Scotland is **band D (61)**.

The potential rating shows the effect of undertaking all of the improvement measures listed within your recommendations report.

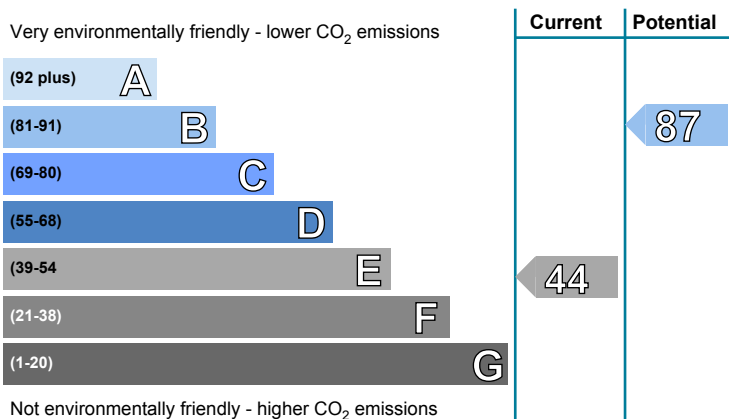
Environmental Impact (CO₂) Rating

This graph shows the effect of your home on the environment in terms of carbon dioxide (CO₂) emissions. The higher the rating, the less impact it has on the environment.
