Home Report

COPPER BEECHES BIFFIE

OLD DEER
PETERHEAD
AB42 5JX

**Walker Fraser Steele
Chartered Surveyors**

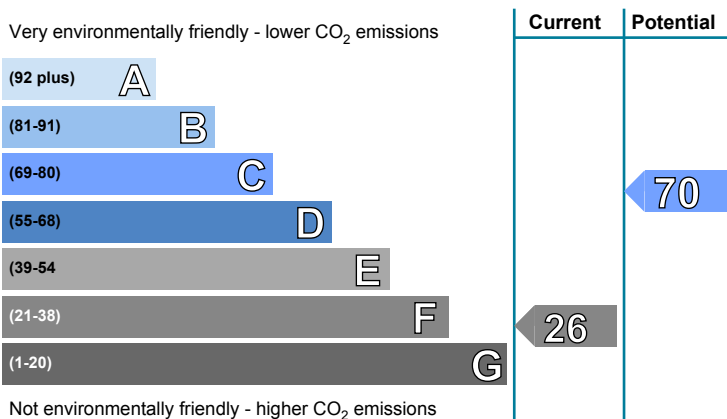
Environmental Impact (CO₂) Rating

This graph shows the effect of your home on the environment in terms of carbon dioxide (CO₂) emissions. The higher the rating, the less impact it has on the environment.

Your current rating is **band F (26)**. The average rating for EPCs in Scotland is **band D (59)**.

The potential rating shows the effect of undertaking all of the improvement measures listed within your recommendations report.
