Home Report

Single Survey

Property address	Drumbeg Rockcliffe Dalbeattie DG5 4QG
Customer	Suzanne Taggart
Customer address	Drumbeg Rockcliffe Dalbeattie DG5 4QG
Prepared by	Shepherd Chartered Surveyors
Date of inspection	01/08/2024

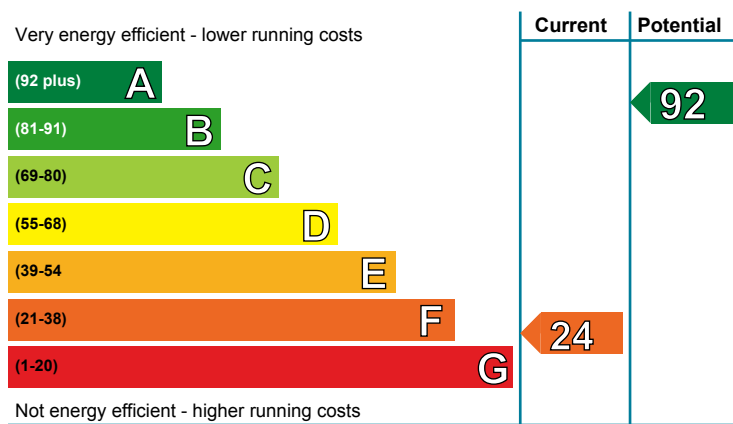
Energy Efficiency Rating

This graph shows the current efficiency of your home, taking into account both energy efficiency and fuel costs. The higher this rating, the lower your fuel bills are likely to be.

Your current rating is **band F (24)**. The average rating for EPCs in Scotland is **band D (61)**.

The potential rating shows the effect of undertaking all of the improvement measures listed within your recommendations report.

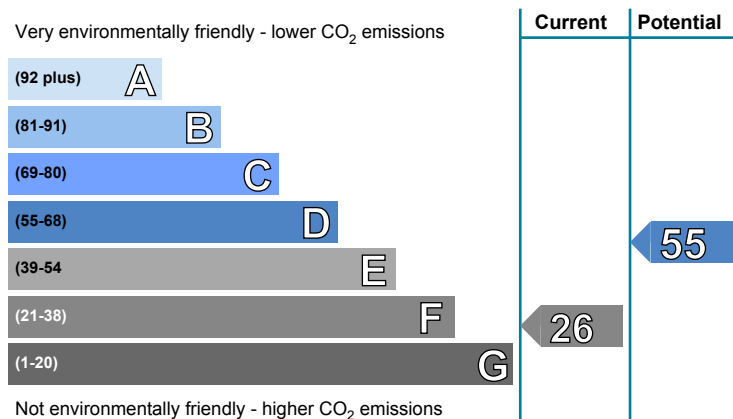
Environmental Impact (CO₂) Rating

This graph shows the effect of your home on the environment in terms of carbon dioxide (CO₂) emissions. The higher the rating, the less impact it has on the environment.
