Home Report

10 Arthurstone House
Meikle
Blairgowrie
PH12 8QW

single survey

Property address	10 Arthurstone House Meikle Blairgowrie PH12 8QW
Customer	Brian & Margaret Cowan
Prepared by	Graham + Sibbald LLP

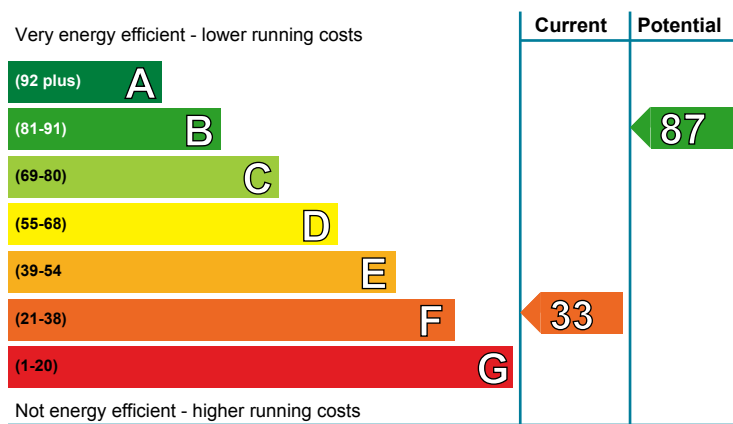
Energy Efficiency Rating

This graph shows the current efficiency of your home, taking into account both energy efficiency and fuel costs. The higher this rating, the lower your fuel bills are likely to be.

Your current rating is **band F (33)**. The average rating for EPCs in Scotland is **band D (61)**.

The potential rating shows the effect of undertaking all of the improvement measures listed within your recommendations report.
