# HOME REPORT

BRAE CROFT SILLYEARN GRANGE

# Energy Performance Certificate (EPC)

**BRAE CROFT SILLYEARN, GRANGE, KEITH, AB55 6SU**

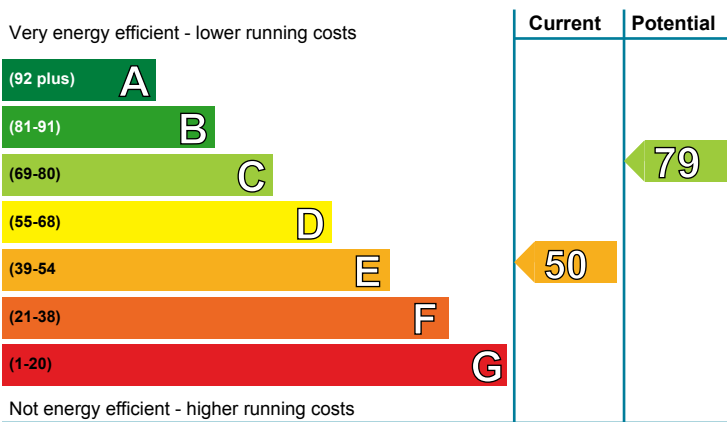
## Energy Efficiency Rating

This graph shows the current efficiency of your home, taking into account both energy efficiency and fuel costs. The higher this rating, the lower your fuel bills are likely to be.

Your current rating is **band E (50)**. The average rating for EPCs in Scotland is **band D (61)**.

The potential rating shows the effect of undertaking all of the improvement measures listed within your recommendations report.

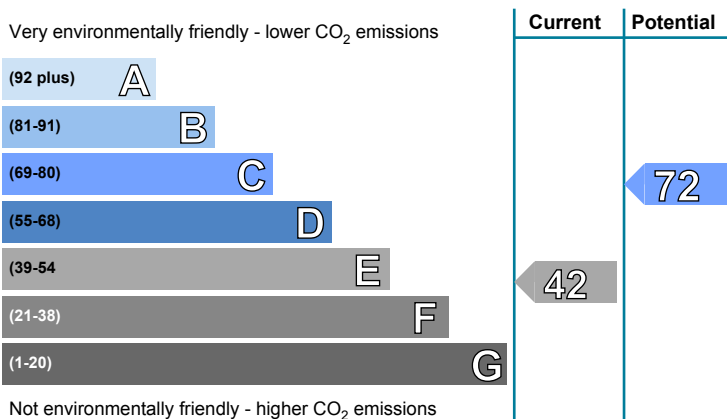
## Environmental Impact (CO<sub>2</sub>) Rating

This graph shows the effect of your home on the environment in terms of carbon dioxide (CO<sub>2</sub>) emissions. The higher the rating, the less impact it has on the environment.

Your current rating is **band E (42)**. The average rating for EPCs in Scotland is **band D (59)**.

The potential rating shows the effect of undertaking all of the improvement measures listed within your recommendations report.
