Home Report

Single Survey

Property address	3 Carlung House Carlung Estate West Kilbride KA23 9PU
Customer	Elizabeth Cunningham
Customer address	3 Carlung House Carlung Estate West Kilbride KA23 9PU
Prepared by	Shepherd Chartered Surveyors
Date of inspection	26/02/2025

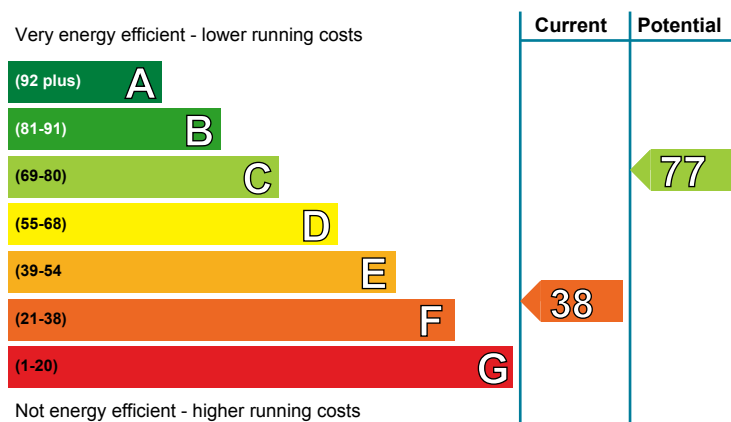
Energy Efficiency Rating

This graph shows the current efficiency of your home, taking into account both energy efficiency and fuel costs. The higher this rating, the lower your fuel bills are likely to be.

Your current rating is **band F (38)**. The average rating for EPCs in Scotland is **band D (61)**.

The potential rating shows the effect of undertaking all of the improvement measures listed within your recommendations report.

Estimated energy costs for your home for 3 years*	£7,620	See your recommendations report for more information
Over 3 years you could save*	£4,578
