Home Report

Scottish Single Survey

Single Survey

Property address	The Moorings Broadstone Road Stranraer DG9 0EX
Customer	Mrs Janice Kerr
Customer address	The Moorings Broadstone Road Stranraer DG9 0EX
Prepared by	Shepherd Chartered Surveyors
Date of inspection	27/02/2025

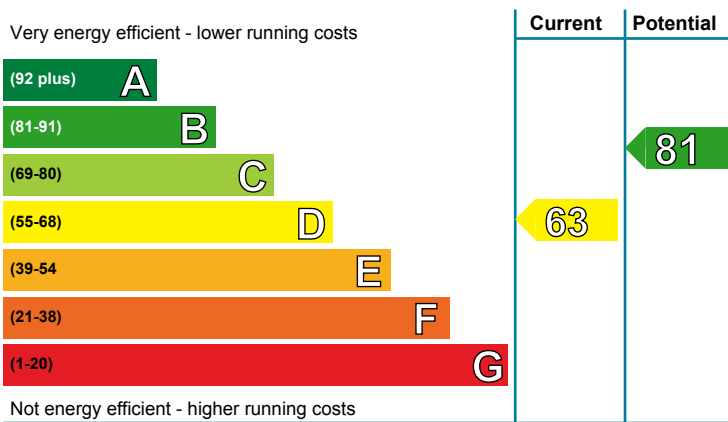
Energy Efficiency Rating

This graph shows the current efficiency of your home, taking into account both energy efficiency and fuel costs. The higher this rating, the lower your fuel bills are likely to be.

Your current rating is **band D (63)**. The average rating for EPCs in Scotland is **band D (61)**.

The potential rating shows the effect of undertaking all of the improvement measures listed within your recommendations report.

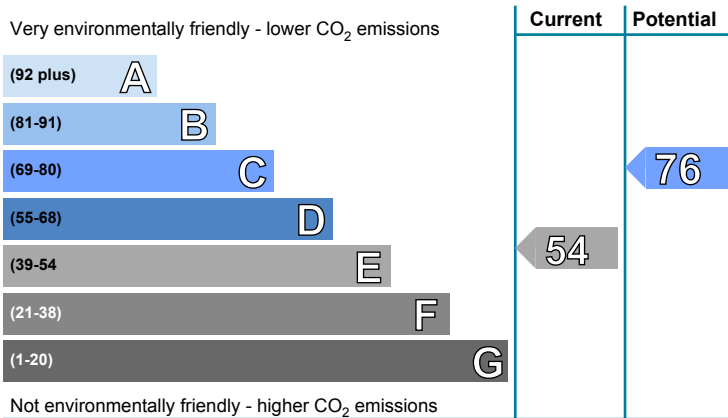
Environmental Impact (CO₂) Rating

This graph shows the effect of your home on the environment in terms of carbon dioxide (CO₂) emissions. The higher the rating, the less impact it has on the environment.
