YOUR ONESURVEY
HOME REPORT

Speyview
Leslie Terrace
Craigellachie, Aberlour
AB38 9SY

SINGLE SURVEY

Single Survey

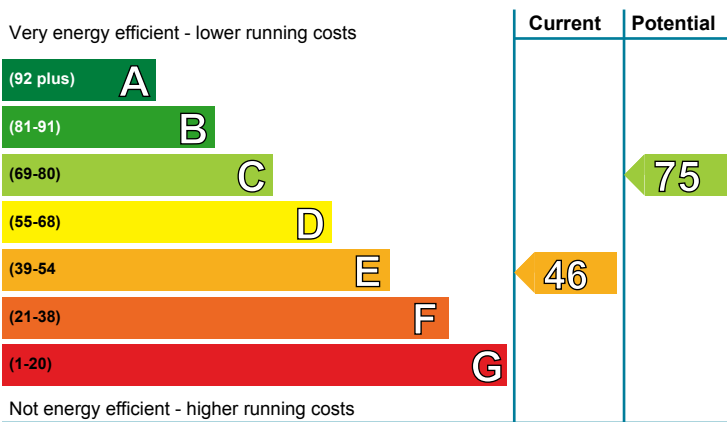
Energy Efficiency Rating

This graph shows the current efficiency of your home, taking into account both energy efficiency and fuel costs. The higher this rating, the lower your fuel bills are likely to be.

Your current rating is **band E (46)**. The average rating for EPCs in Scotland is **band D (61)**.

The potential rating shows the effect of undertaking all of the improvement measures listed within your recommendations report.
