# **HOME REPORT**

#### **GLENHEAD OF COACHFORD CAIRNIE**

**HUNTLY AB54 4TU**

# survey report on:

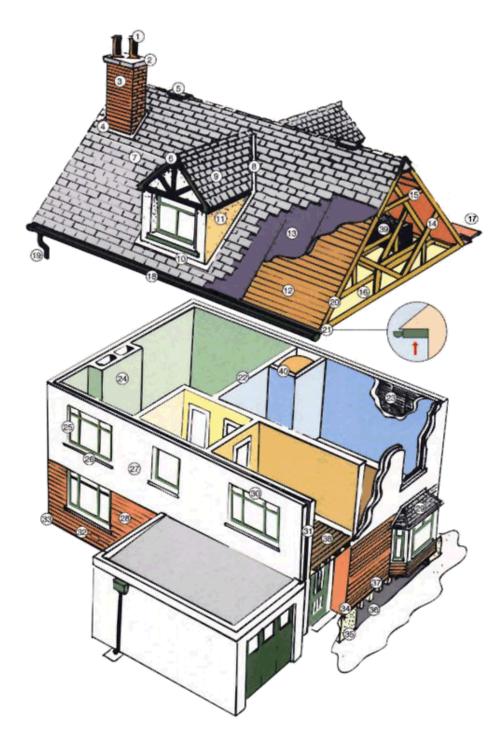
#### Sectional Diagram showing elements of a typical house

Reference may be made in this report to some or all of the above component parts of the property. This diagram may assist you in locating and understanding these items.

- 1) Chimney pots
- 2) Coping stone
- 3) Chimney head
- 4 Flashing
- 5 Ridge ventilation
- 6 Ridge board
- 7) Slates / tiles
- 8 Valley guttering
- 9 Dormer projection
- 10) Dormer flashing
- 11) Dormer cheeks
- 12) Sarking
- 13) Roof felt
- (14) Trusses
- (15) Collar
- 16 Insulation
- (17) Parapet gutter
- 18) Eaves guttering
- (19) Rainwater downpipe
- 20) Verge boards/skews
- 21) Soffit boards
- 22) Partition wall
- 23) Lath / plaster
- (24) Chimney breast
- (25) Window pointing
- 6) Window sills
- 27) Rendering
- (28) Brickwork / pointing
- 29) Bay window projection
- 30 Lintels
- (31) Cavity walls / wall ties
- 32) Subfloor ventilator
- (33) Damp proof course
- 34) Base course
- (35) Foundations
- 36) Solum
- (37) Floor joists
- (38) Floorboards
- 39) Water tank
- 40 Hot water tank
