Home Report

Blawearie House

single survey

survey report on:

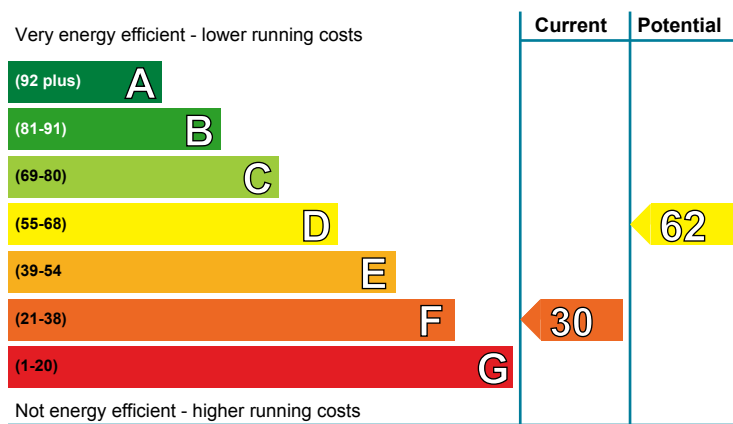
Energy Efficiency Rating

This graph shows the current efficiency of your home, taking into account both energy efficiency and fuel costs. The higher this rating, the lower your fuel bills are likely to be.

Your current rating is **band F (30)**. The average rating for EPCs in Scotland is **band D (61)**.

The potential rating shows the effect of undertaking all of the improvement measures listed within your recommendations report.
