YOUR ONESURVEY  
**HOME REPORT**

Pennyfadzeoch Farm  
Ochiltree, Cumnock  
KA18 2NL

# SINGLE SURVEY

# energy report

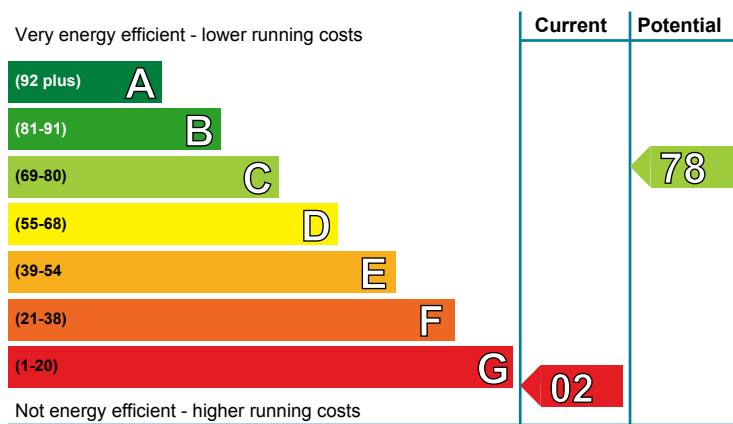
## Energy Efficiency Rating

This graph shows the current efficiency of your home, taking into account both energy efficiency and fuel costs. The higher this rating, the lower your fuel bills are likely to be.

Your current rating is **band G (2)**. The average rating for EPCs in Scotland is **band D (61)**.

The potential rating shows the effect of undertaking all of the improvement measures listed within your recommendations report.
